Cracks found in Schleicher ASK21 elevator drive rocker

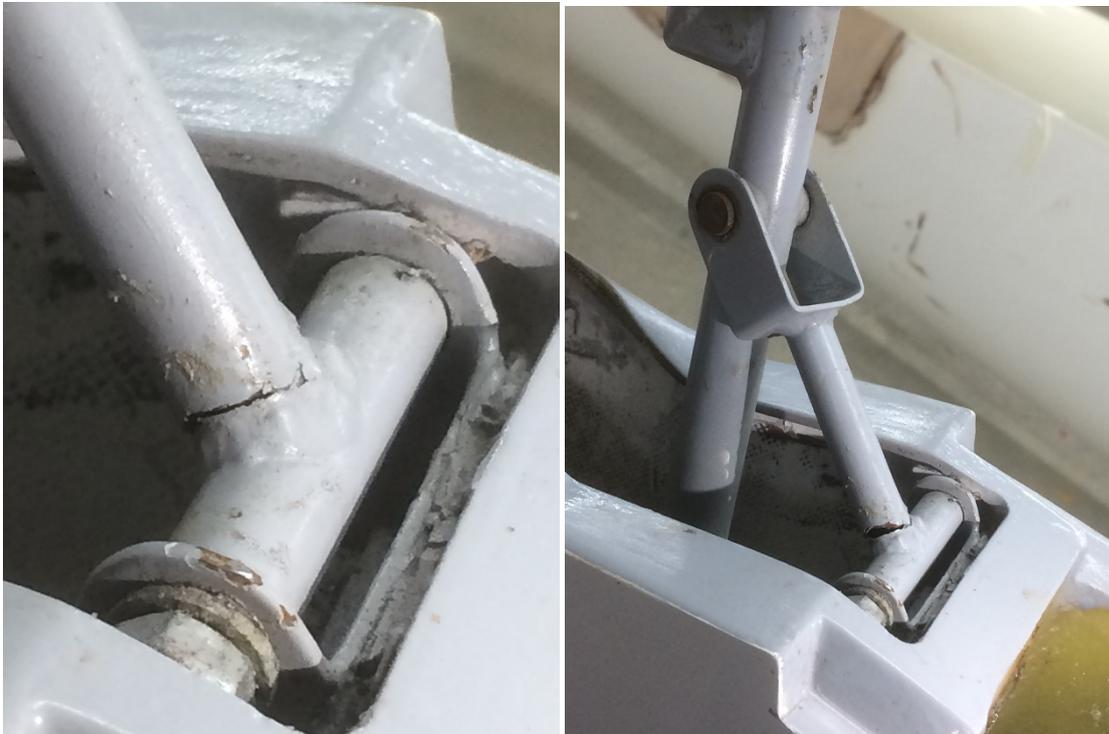
The fracture was along the outer edge of the weld connecting the arm of the rocker to the pipe that houses that attachment bolt of the rocker. Just over 1/3 of its diameter was cracked, and the application of a small sideways pressure resulted in complete failure of the rocker arm. Small amounts of corrosion were visible in the initial crack, suggesting a fatigue crack slowly progressing over time.

Hairline crack in rocker arm (left), and failed rocker arm (right) after application of small force.

Inspection of other ASK-21s in the same fleet showed that a different design of rocker arm was fitted. The rocker arm was wider, with an oval shape better suited to withstand sideways pressure. The ASK-21 affected by the fracture, was flying with an older design part. Its maintenance records show that TM22 was carried out by the previous owner of the aircraft. The TM was signed off, but no specific mention was made if the affected part was replaced as the TM requires (terminating action). Further information supplied by the tc-holder (drawing 99.000.4940 Rev. 1) reveals the part installed in the affected aircraft is not the part required to be installed by TM22, but the original design. It is no longer possible to establish if TM22 was not fully carried out (i.e. part not replaced) by the previous owner, or if the affected part was installed by accident in a later stage during maintenance with the previous owner.

The TM also explicitly states that any trailer used to house an ASK-21 for transport is not allowed to have padding in the 'chimney' of the trailer, as this causes sideways loading of the affected part. The trailer of the aircraft in question is not fitted standard with padding, but upon inspection was found to have a small cushion jammed in there. This was removed. However, the extremely low yearly mileage the trailer does with an ASK-21 (estimated less than 100 km average a year) would make this only a minor contributing factor to the cracking.

- TM22 has been carried out in full. The affected part was replaced by the correct part.
- A full survey of all historical AD's, LTA's and TM's was undertaken for this aircraft. No other oversights were found.
- All pilots have been reminded of the need not to put any cushions in the 'chimney' of the trailer to secure the fuselage during road transport.

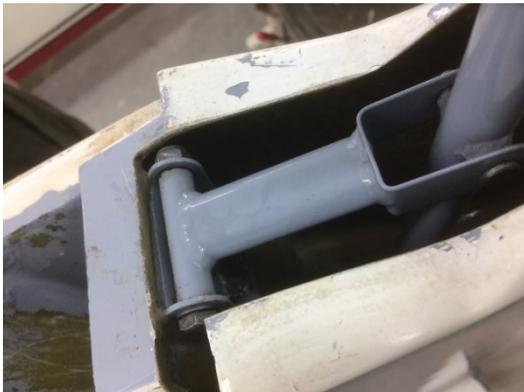
Modified wider design rocker arm as fitted after TM22.

TC-holder Alexander-Schleicher Segelflugzeugbau GmbH. issued [TM22](#) on November 26, 1990. This details the inspection of the rocker arm for cracks, and mandatory replacement before the next annual inspection or before April 31st, 1991. It also covers flight manual pages exchange.
