Report of defect to PIK-20D PH-666 October 2018

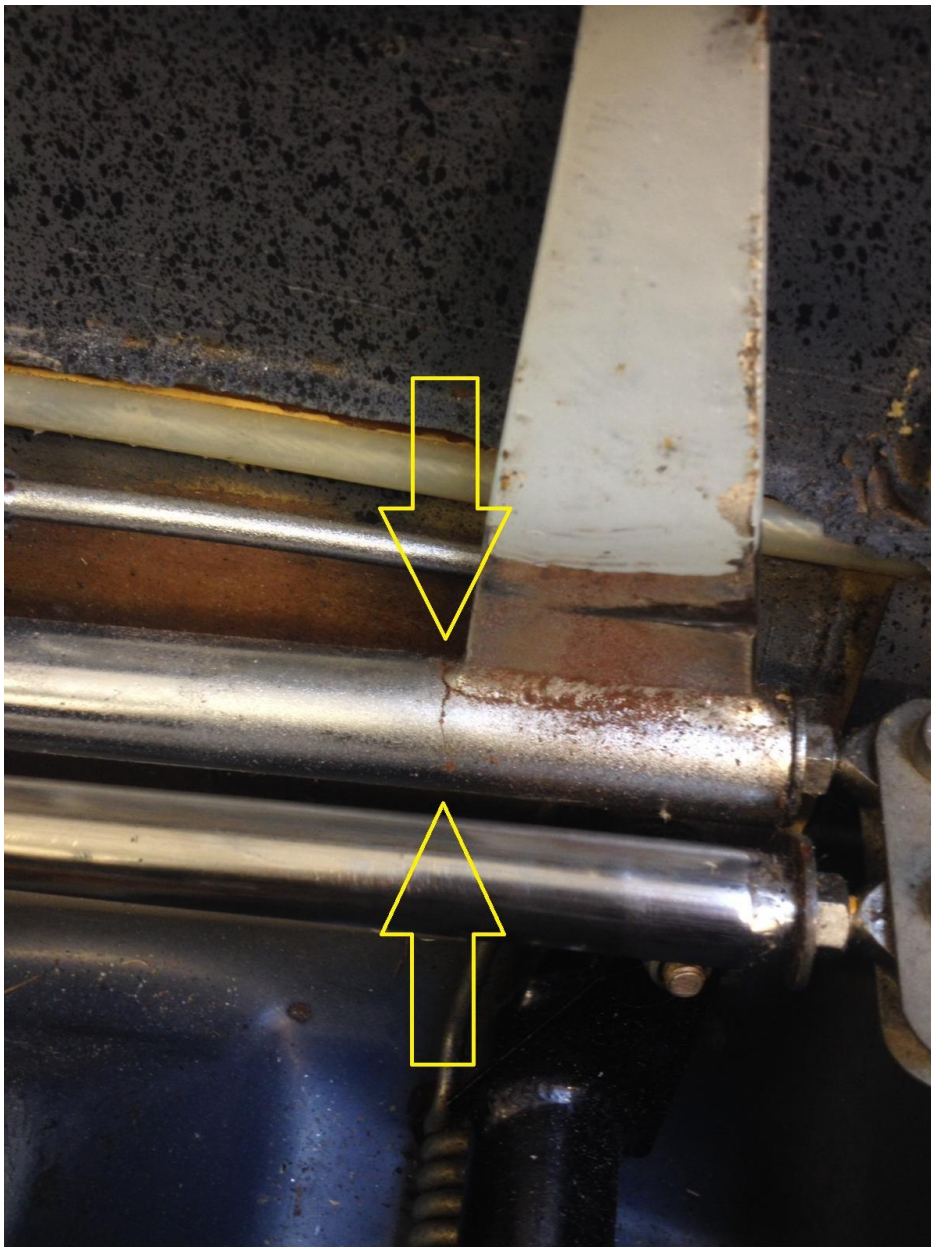
During routine maintenance to Eirivion PIK-20D PH-666 a fracture was found in the airbrake control rod in the cockpit, just aft of the vertical airbrake lever grip of the pilot (see photo). The crack originated from the weld of the vertical lever grip to the horizontal control rod, on the topside of the rod, and propagated down in a radial manner across the rod approx. $\frac{1}{2}$ of the diameter of the rod. It is a fatigue crack, most likely. Light surface corrosion was present, but is thought not to be a major causal factor. The aircraft was delivered to a certified repair shop for repair to the standards set by the manufacturer. The control rod would have eventually failed, leading to reduced airbrake control, or uncommanded airbrake control inputs.

Photo 1: crack in control rod (RH side of photo is in direction of flight).
